Report: Sample Report for Website Address:

Confidential Inspection Report

February 8, 2010

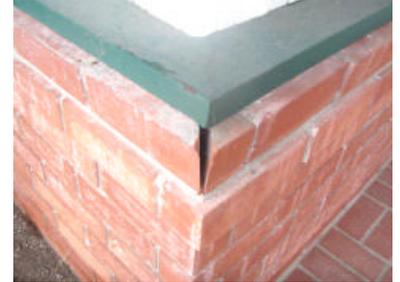
2. Stucco; Brick; Loose brick siding at front of structure, needs repair to prevent further loosening.

Siding: Stucco; Brick; Loose brick siding at front of structure, needs repair to prevent further loosening.

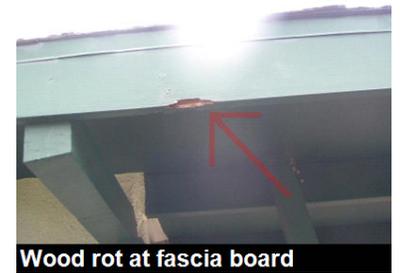
3. Deteriorated wood at several areas of exterior trim, see termite report for details.

Trim: Deteriorated wood at several areas of exterior trim, see termite report for details.

Wood rot at fascia board

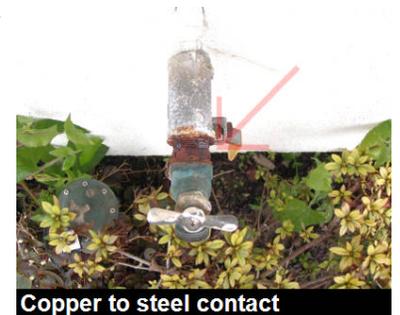
4. Rust at rear exterior hose faucet caused by copper to steel contact, a new fitting should be installed.

Hose Faucets: Rust at rear exterior hose faucet caused by copper to steel contact, a new fitting should be installed.

Copper to steel contact

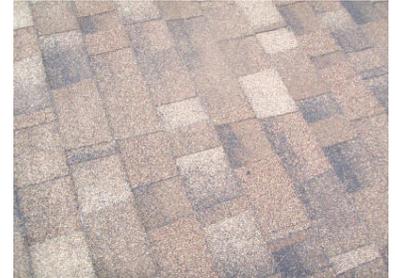
Granular loss at shingles due to age

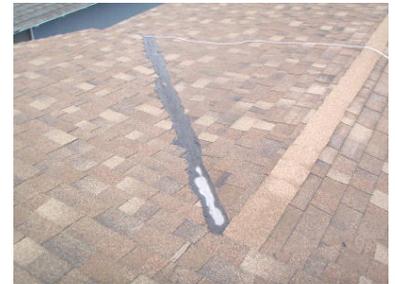
5. The roof materials are beginning to show typical signs of ageing, no maintenance appears to be necessary at this time. The roof should continue to be monitored for wear/ leakage. The ridge caps have been replaced and the rear left valley has been patched (water staining in master bathroom).

The roof materials are beginning to show typical signs of ageing, no maintenance appears to be necessary at this time. The roof should continue to be monitored for wear/ leakage. The ridge caps have been replaced and the rear left valley has been patched (water staining in master bathroom).

Patching at rear valley

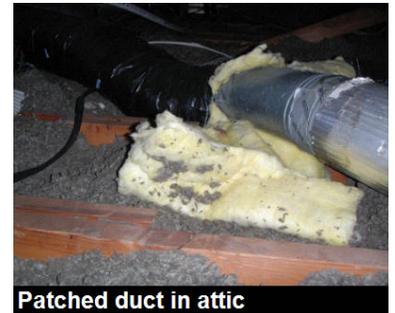
7. Patching visible at several areas of attic ducting.

Patching visible at several areas of attic ducting.

Patched duct in attic

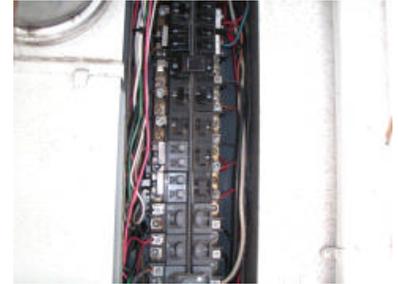
9. Double-tapping present at breaker(s). Multiple wires plugged into one circuit breaker can be potentially hazardous due to overload. A licensed contractor should be consulted. An upgrade/ replacement of the electrical panel is suggested due to make (Bulldog breakers), consult a licensed electrician for options.

Electrical Comments: Double-tapping present at breaker(s). Multiple wires plugged into one circuit breaker can be potentially hazardous due to overload. A licensed contractor should be consulted. An upgrade/ replacement of the electrical panel is suggested due to make (Bulldog breakers), consult a licensed electrician for options.

Double tap on breaker

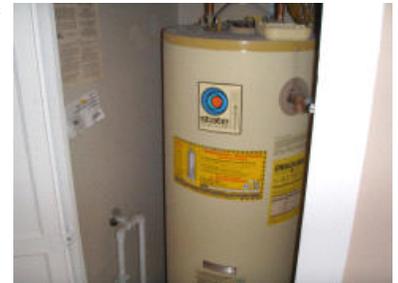
Pressure Release & Discharge Line: The water heater is equipped with the required pressure release device but it lacking the discharge piping. The piping should extend either to the exterior or terminate no higher than six inches off the floor. Contacting a licensed plumber is suggested.

Earthquake Strapping: The earthquake strapping on the water heater is improperly installed, the straps are required to wrap around the tank 1/3 from the bottom and 1/3 from the top prior to bolting to a wall stud.

Due to the location of the water heater (interior), the installation of a pan with discharge line is suggested.

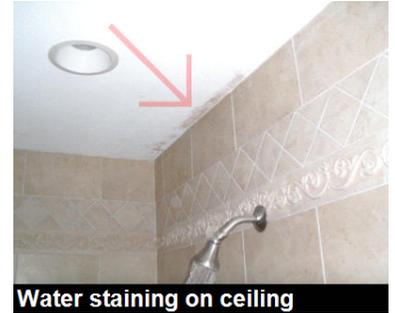
17. Cracked floor tile in bathroom. Leak under the right sink at the trap. The shower walls need re-caulking and the weatherstripping at shower door has eroded. The left sink faucet handles are misaligned. There is water staining

on the ceiling above the shower, see roof comments. The jacuzzi tub pump water lines are leaking (access is in the hall closet), consult licensed plumber.

Cracked floor tile in bathroom. Leak under the right sink at the trap. The shower walls need re-caulking and the weatherstripping at shower door has eroded. The left sink faucet handles are misaligned. There is water staining on the ceiling above the shower, see roof comments. The jacuzzi tub pump water lines are leaking (access is in the hall closet), consult licensed plumber.

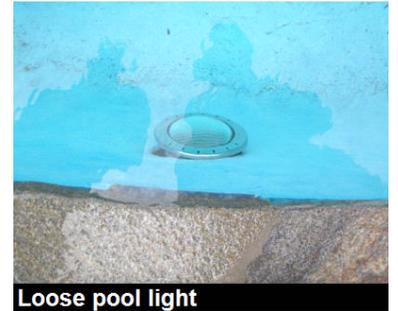
22. The pool light is loose on the wall, licensed electrician or pool specialist should be contacted as this represents a safety hazard.

The pool light is loose on the wall, licensed electrician or pool specialist should be contacted as this represents a safety hazard.

Loose pool light
