Thoroughspec Home Inspections
6161 Chapman Ave
Garden Grove CA 92845
714-404-3392
thoroughspec@gmail.com thoroughspec.com

Confidential Inspection Report

**1234 Main St
Huntington Beach CA 92646**

July 18, 2016

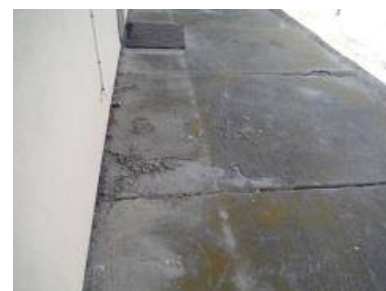
2.1 Driveways/Walkways:

Concrete; Cracked and damaged concrete walkways.

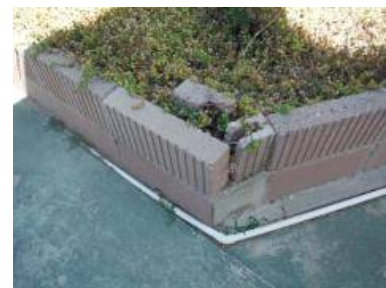
2.2 Fencing/Gates:

Block; Wrought iron; Step cracking and loose wall blocks at right and left side walls. Damaged block planters.

Block; Wrought iron; Step cracking and loose wall blocks at right and left side walls.
Damaged block planters.

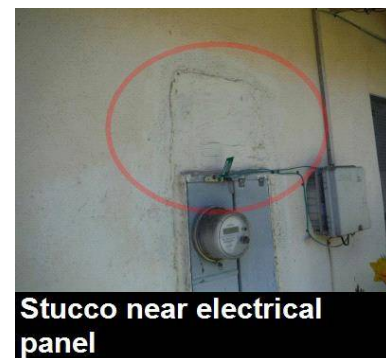
2.3 Siding:

Stucco; Brick; Stucco near electrical panel right side is poorly patched. Common hairline cracking and chipping at walls, typical of age of structure.

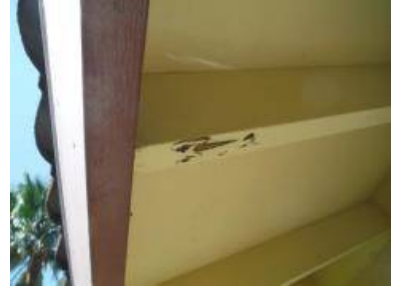
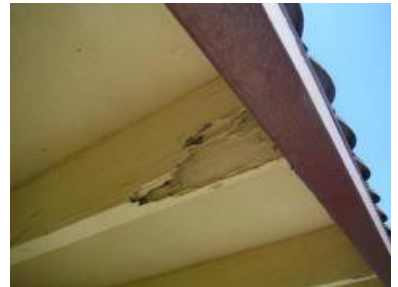
2.4 Trim:

The termite report should be reviewed as deteriorated wood was visible at multiple areas.

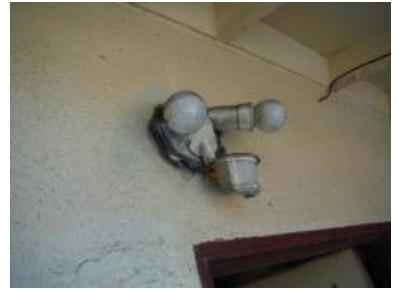
2.6 Electrical Fixtures:

The doorbell was inoperable when tested. Loose electrical fixtures on front and rear walls.

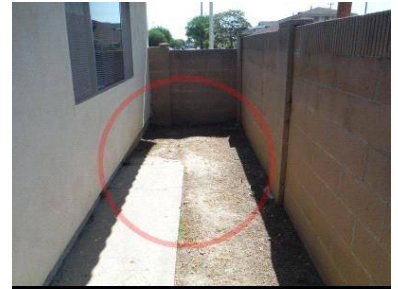
2.10 Lot Grading/Drainage:

Structure is located on a flat lot. Grading at some areas is suggested to prevent water from pooling in low spots. Install holes at base of left wall to allow water to escape yard.

Water will pond in this area

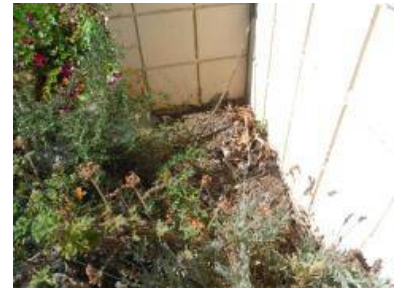
2.12 Exterior Comments:

Moisture barriers are required between planters and exterior walls to prevent water penetration, installation is needed at front planters.

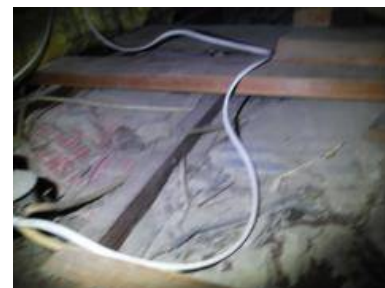
3.3 Insulation:

The attic is minimally insulated, twelve inches of insulation is recommended for the Southern California climate. Adding insulation is an effective method of lowering energy costs.

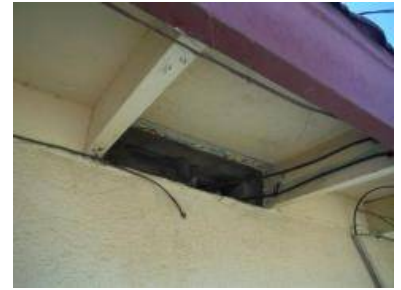
3.4 Ventilation:

Torn attic vent screens in eaves, repair to prevent pest intrusion into attic.

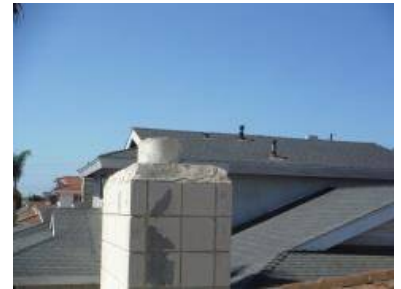
3.6 Chimney:

The chimney is lacking a spark arrestor, required for wood burning fireplaces to prevent embers from escaping. The mortar at the chimney cap is cracked and in need of repair, contact licensed contractor.

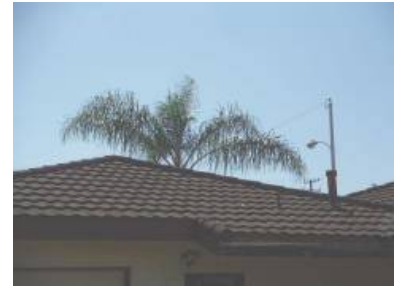
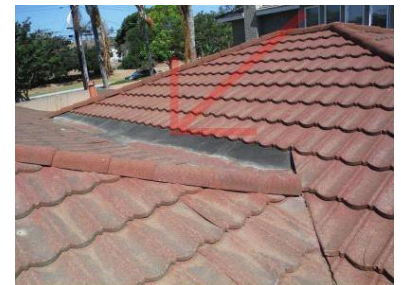
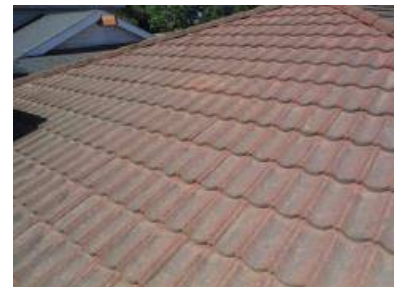
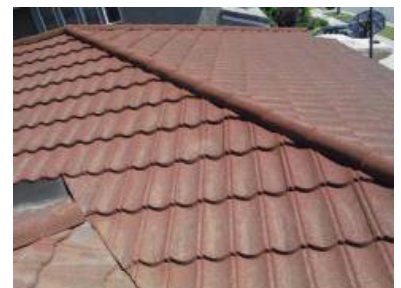
3.9 Roofing:

The roof was visually inspected from accessible vantage points as it is composed of materials that can be damaged if walked upon. Unless otherwise noted in the report, the roof is in serviceable condition. There is a small area of roll roofing in valley at right side, this area will require periodic sealing to prevent leakage.

This area will need periodic sealing

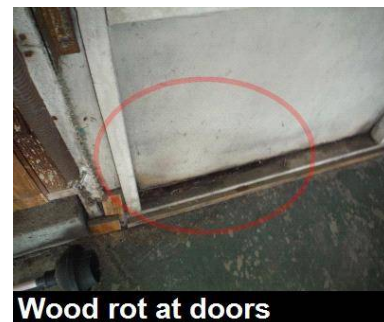
4.3 Overhead Door:

The garage doors show deterioration, replacements are suggested.

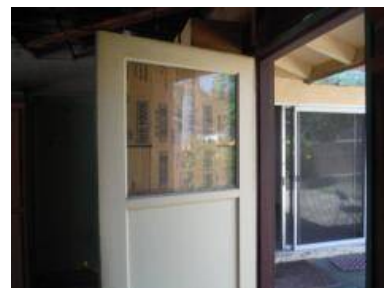
4.5 Man Door/ Windows:

Common with older structures, the glass used at doors/ windows is non-tempered. Non-tempered glass may shatter when cracked unlike current panes. A review by a licensed window contractor is suggested for upgrade options.

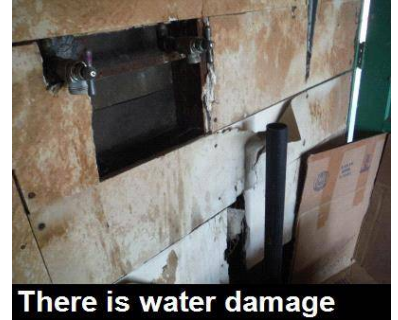
The garage walls show typical wear and tear (cosmetic damage). There is water damage to rear wall drywall.

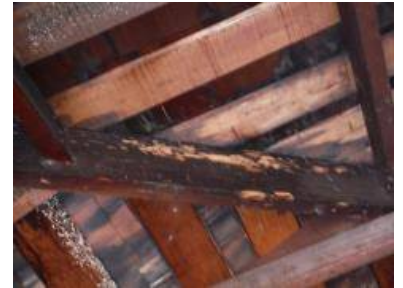
4.8 Garage Ceiling/ Rafters:

Deteriorated wood at garage framing/ rafters.

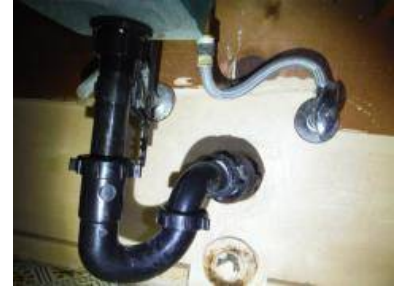
Shut off valves under sinks and toilets can become frozen if left untouched for an extended period of time. Replacement of frozen valves is suggested in this structure to allow for usage. Contact a licensed plumbing contractor for repair.

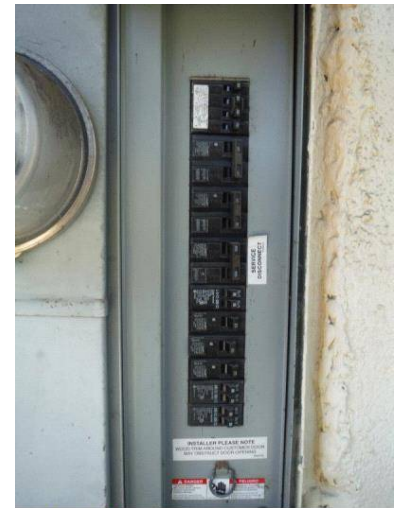
7.8 Main Panel Comments:

The electrical panel is missing the legend (labeling) at some or all circuits. Each breaker must be listed as to which circuit it controls.

Label the breakers

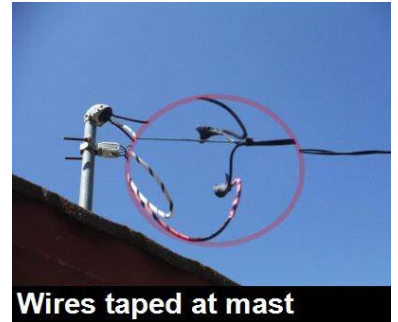
7.9 Electrical System Comments:

Common for electrical systems in the late 1950's to mid 1960's, outlets are grounded near water sources only (kitchen and bathrooms typically). The electrical service lines at mast are attached with tape, contact licensed contractor for permanent attachment (connectors).

Wires taped at mast

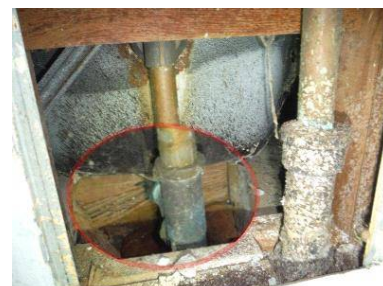
Bathroom located off hallway; The installation of GFCI (ground fault circuit interrupter) outlets are required in bathrooms for safety. Contact licensed plumbing contractor for roofer service as drain is slow at tub. The tub drain is leaking (access in master bathroom), contact licensed contractor for repair. There is a chip in the tub. Drip at the sink faucet. The tub hardware is worn and leaks when operated. Improper installation (exposed wire) at overhead exhaust fan, this is a safety hazard.

Leaking tub drain

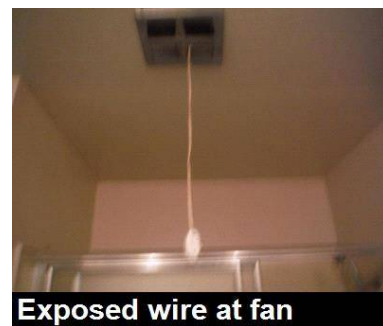
Exposed wire at fan

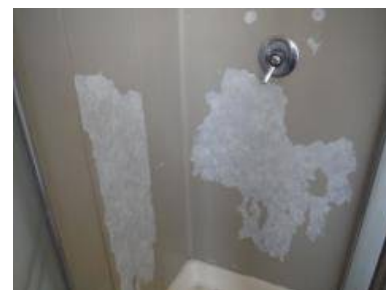
10.2 Bathroom#2 Location/ Comments:

The bathroom is located off of the master bedroom; The shower wall panels are delaminated. The overhead light fixture is damaged. The installation of GFCI (ground fault circuit interrupter) outlets are required in bathrooms for safety.

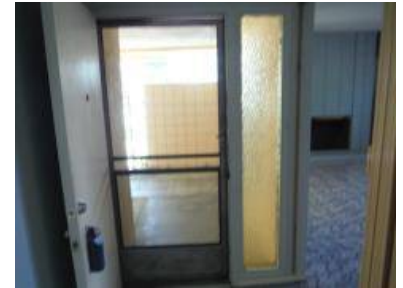
11.1 Entry Way Comments:

Common with older structures, the glass used at doors/ windows is non-tempered. Non-tempered glass may shatter when cracked unlike current panes. A review by a licensed window contractor is suggested for upgrade options.
