Inspection reference: 26113

## Confidential Inspection Report

1234 Main St  
Huntington Beach CA 92648

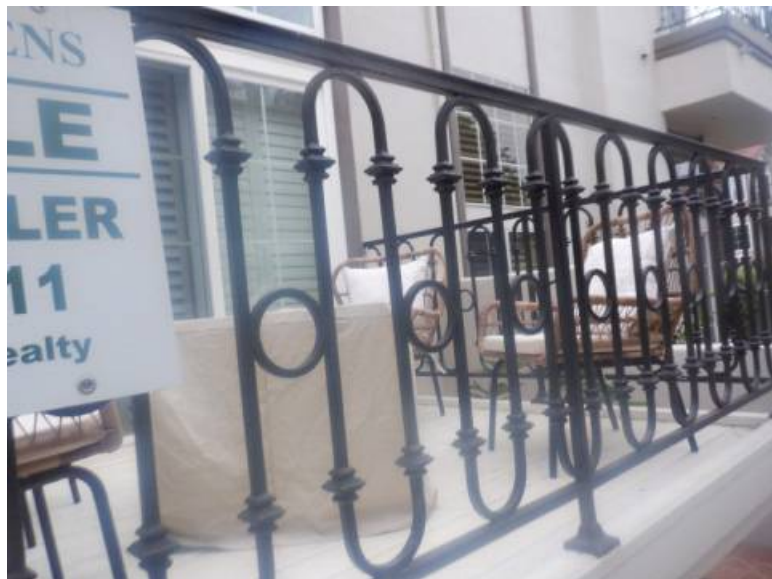
Balconies (two front, two rear): The current maximum distance between balusters or between a post and baluster, in California building minimum standards, is 4 inches. The space between the finished floor and the bottom rail must not exceed 4 inches. This became the standard in 1997, structures that pre-date this standard often have much larger gaps. While replacement is not required when transferring title of property, any newly installed railing must meet current requirements.

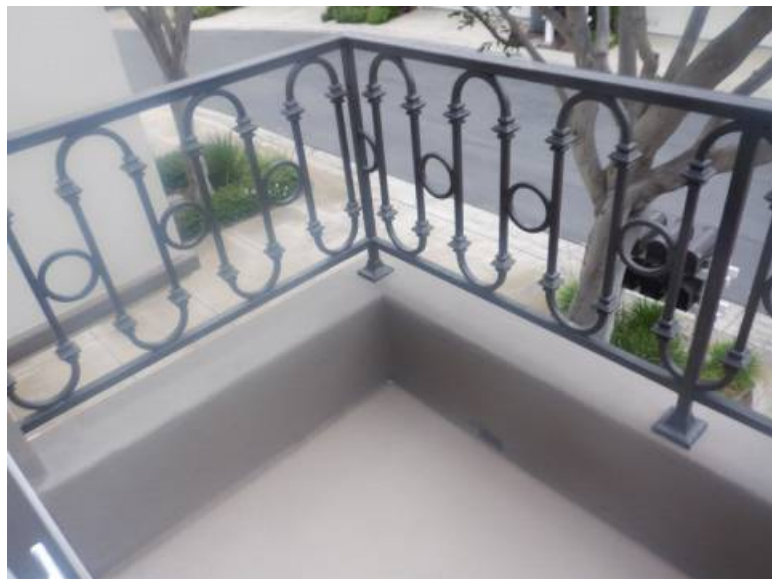
Balcony; The current maximum distance between balusters or between a post and baluster, in California building minimum standards, is 4 inches. The space between the finished floor and the bottom rail must not exceed 4 inches. This became the standard in 1997, structures that pre-date this standard often have much larger gaps. While replacement is not required when transferring title of property, any newly installed railing must meet current requirements.

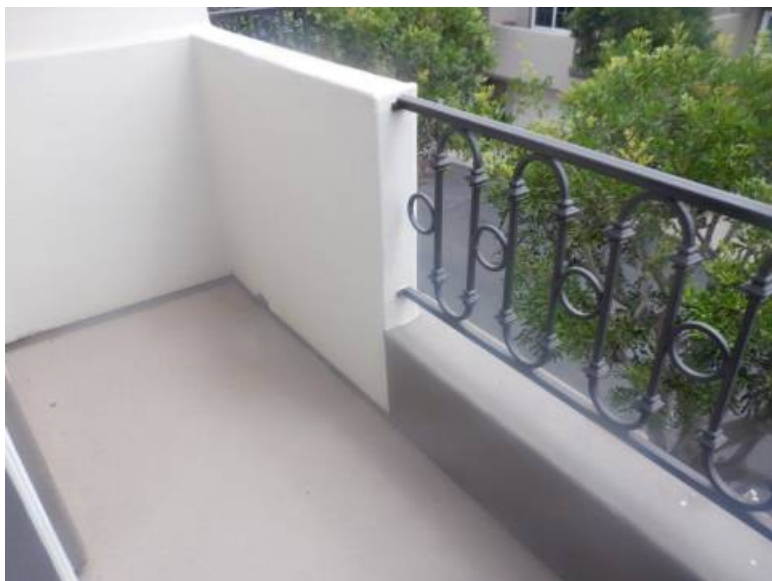
Balcony; The current maximum distance between balusters or between a post and baluster, in California building minimum standards, is 4 inches. The space between the finished floor and the bottom rail must not exceed 4 inches. In addition, the minimum balustrade height is 42 inches. This became the standard in 1997, structures that pre-date this standard often have much larger gaps. While replacement is not required when transferring title of property, any newly installed railing must meet current requirements.

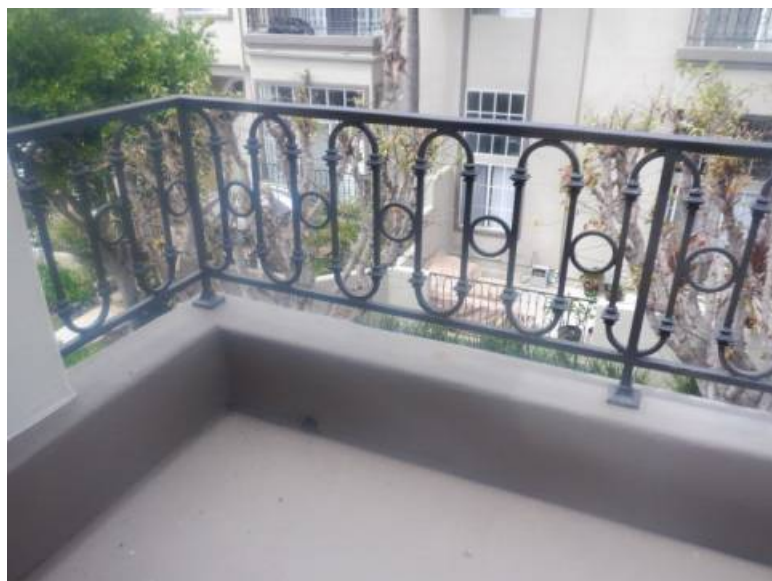
Balcony; The current maximum distance between balusters or between a post and baluster, in California building minimum standards, is 4 inches. The space between the finished floor and the bottom rail must not exceed 4 inches. In addition, the minimum balustrade height is 42 inches. This became the standard in 1997, structures that pre-date this standard often have much larger gaps. While replacement is not required when transferring title of property, any newly installed railing must meet current requirements.

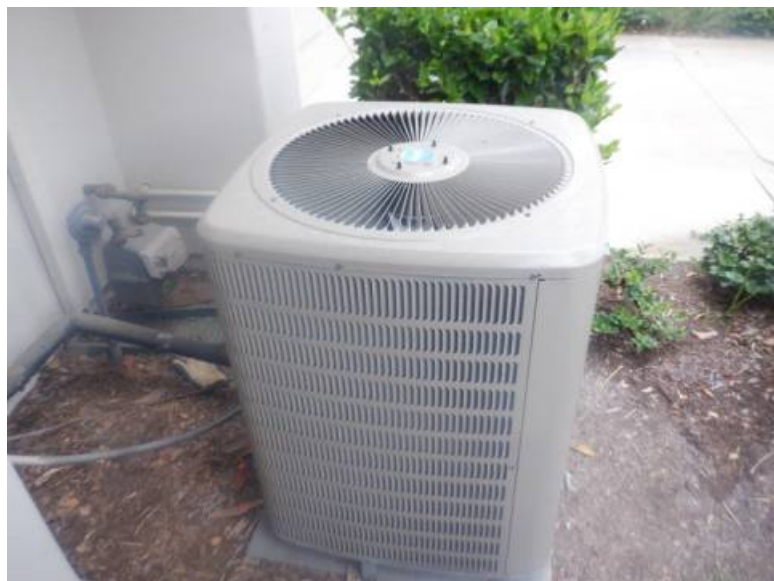
Contact a licensed HVAC technician as the air conditioning compressor was found to be inoperable at time of inspection.

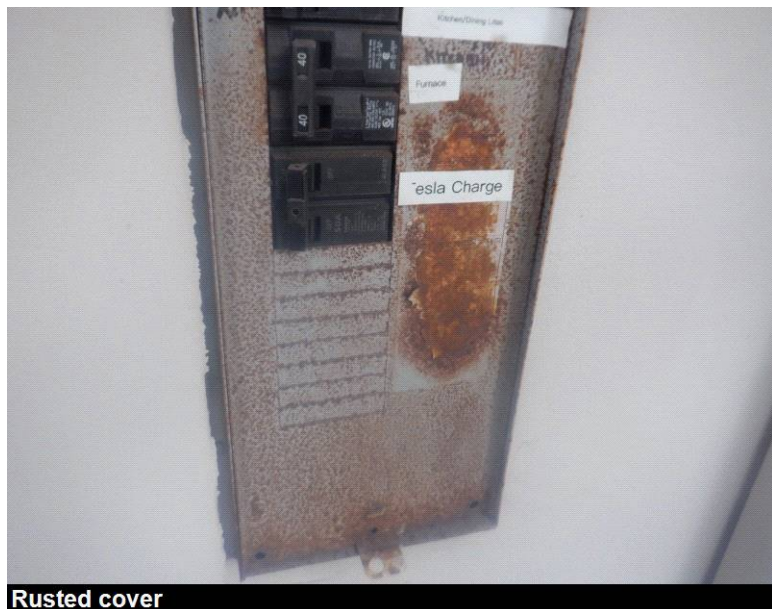
The electrical panel deadfront (cover) is corroded. Corrosion will lead to shortened useful life of panel. Apply rust resistant paint to extend panel cover useful life.

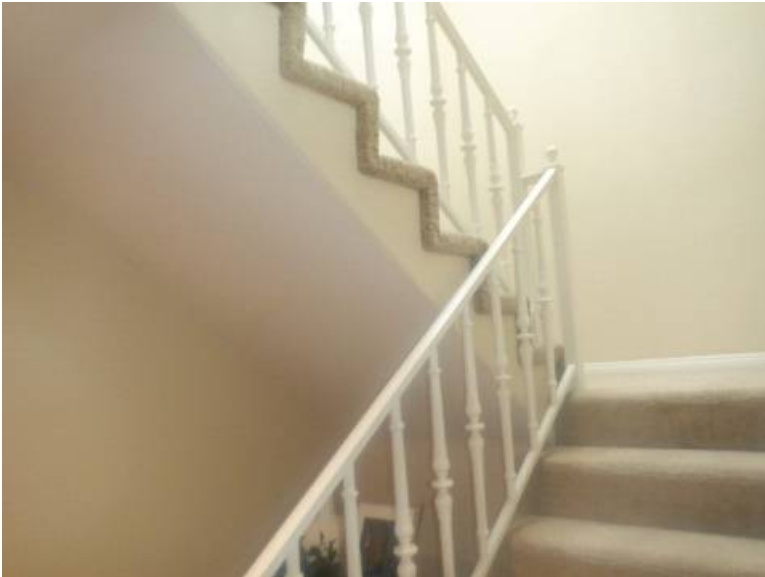
The gaps at the railings and/ or treads are larger than allowed by current building standards. The maximum distance between balusters or between a post and baluster, in the California building code, is 4 inches. The space between the finished floor and the bottom rail must not exceed 4 inches. In addition, the minimum balustrade height is 42 inches. Though replacement of railings are not required to transfer title of property, any newly installed railings must meet current standards.
