Inspection reference: 19283

# Confidential Inspection Report

123 Homeowner Way  
Irvine CA 92620

September 26, 2019

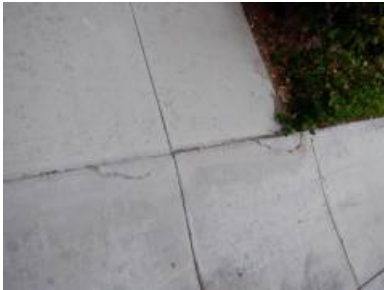
#### 2.1 Driveway/ Walkways:

Concrete; Asphalt; Common cracking visible at driveways and walkways.

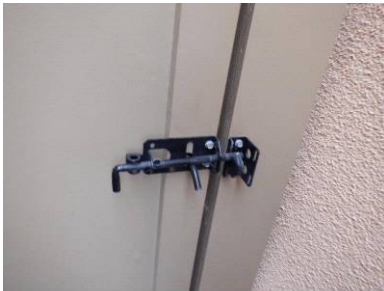
#### 2.2 Fencing/ Gates:

Block; Wood; Inoperable latch at rear wood gate.

**Inoperable latch**

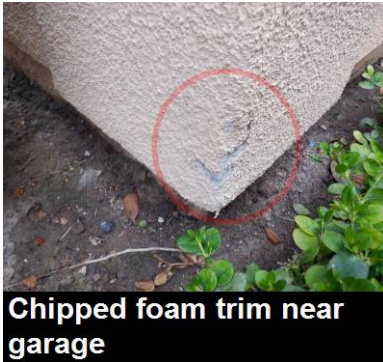
Wood; Foam; Decorative foam trim is often used around doors and windows of modern homes. This material (PolyStyrene Foam) is susceptible to physical damage and may chip. As some chipping is present, cosmetic repairs are needed (patch and paint).

**Chipped foam trim near garage**

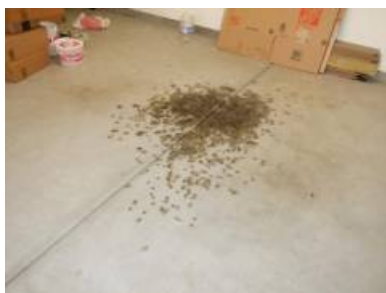
#### 4.2 Garage Slab:

Concrete; The garage slab shows cosmetic staining.

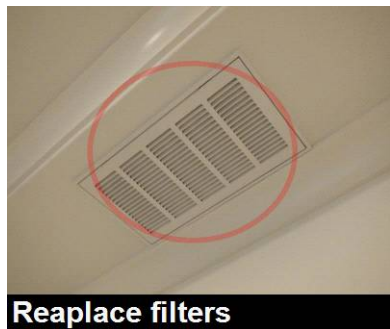
The heater filter(s) are dirty and currently requires replacement. Dirty filters can damage the blower motor and cause staining to walls near the registers. Filters are typically changed three to four times per year, more often if you have allergies or pets in the home.

Reaplace filters

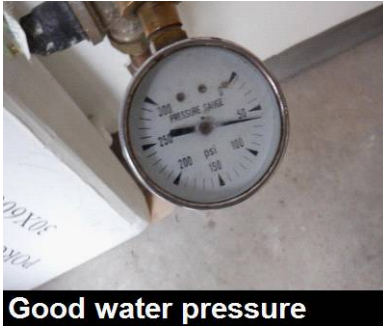
#### 6.6 Main Line Comments:

Residential water pressure tends to range between 45 and 80 psi (pounds per square inch). Anything below 40 psi is considered low and anything below 30 psi is considered too low; the minimum pressure required by most codes is 20 psi. Pressures above 80 psi are too high. High water pressure carries with it a significantly increased risk of damage to pipes, joints, fixtures and seals - not to mention increased water waste. Water pressure (PSI) taken at main at time of inspection was between 45 and 80 as needed.

Good water pressure

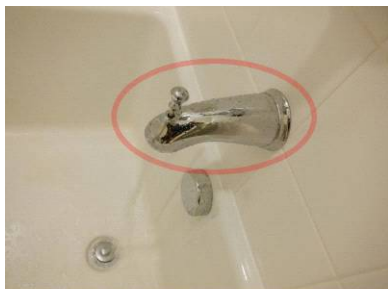
#### 10.2 Bathroom #2 Location/ Comments:

Upstairs Hall; The tub diverter is not diverting enough of the water to the showerhead as intended, replace the tub spout.

**Replace the tub spout**

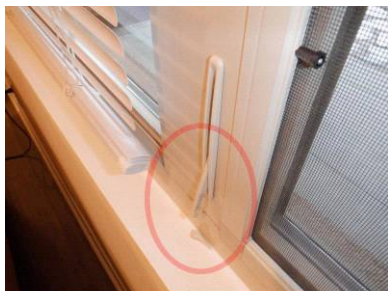
#### 11.2 Living Room Comments:

Damaged latch handle at the rear left window.

**Damaged latch handle**

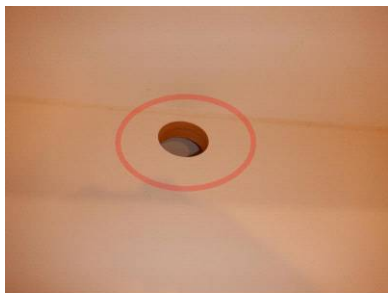
#### 11.4 Hallway Comments:

Missing flanges at built-in desk cable management grommet openings.

**cable management  
grommet opening**
