Inspection reference: 26113

## Confidential Inspection Report

1234 Main St  
Huntington Beach CA 92648

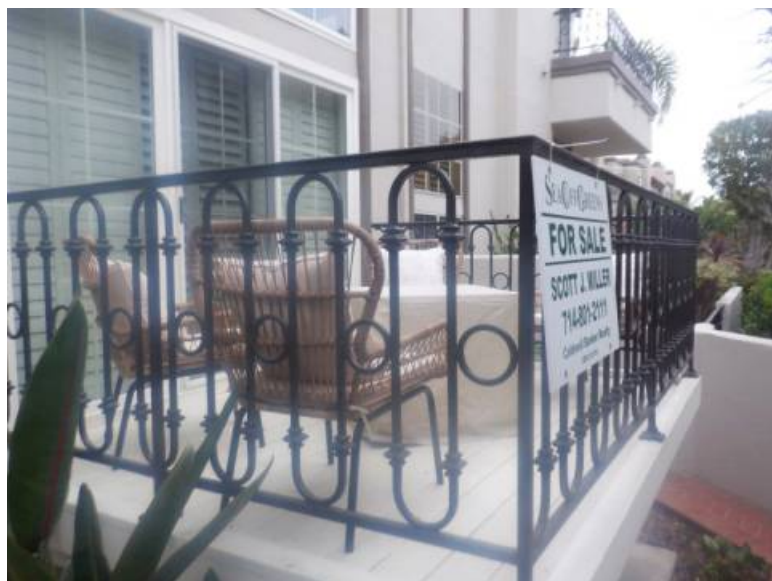
Balconies (two front, two rear): The current maximum distance between balusters or between a post and baluster, in California building minimum standards, is 4 inches. The space between the finished floor and the bottom rail must not exceed 4 inches. This became the standard in 1997, structures that pre-date this standard often have much larger gaps. While replacement is not required when transferring title of property, any newly installed railing must meet current requirements.

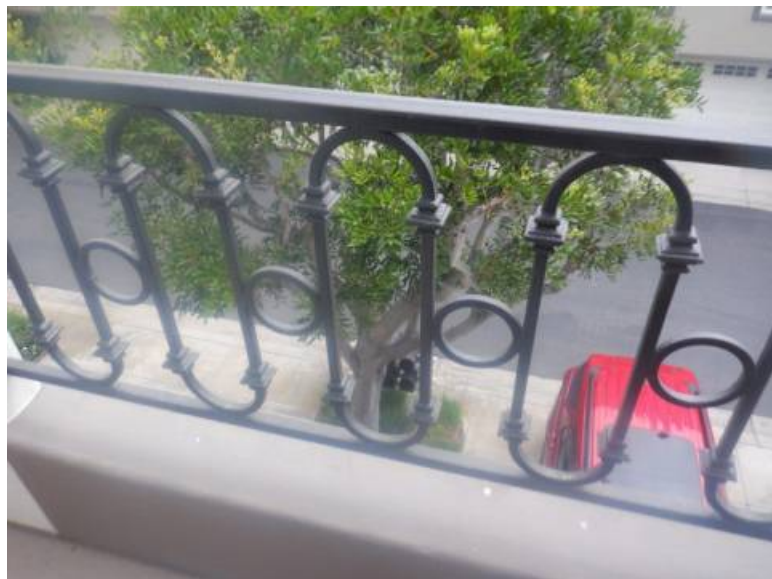
Balcony; The current maximum distance between balusters or between a post and baluster, in California building minimum standards, is 4 inches. The space between the finished floor and the bottom rail must not exceed 4 inches. In addition, the minimum balustrade height is 42 inches. This became the standard in 1997, structures that pre-date this standard often have much larger gaps. While replacement is not required when transferring title of property, any newly installed railing must meet current requirements.

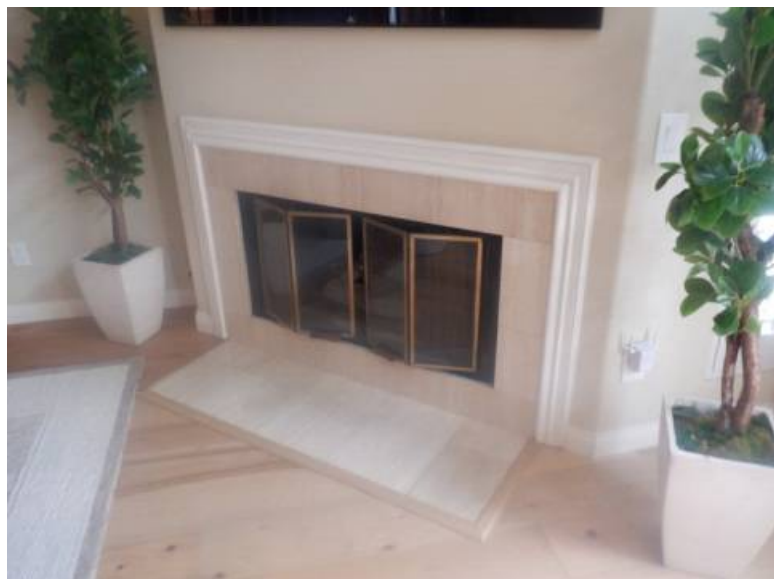
The fireplace operated properly with no defects visible.

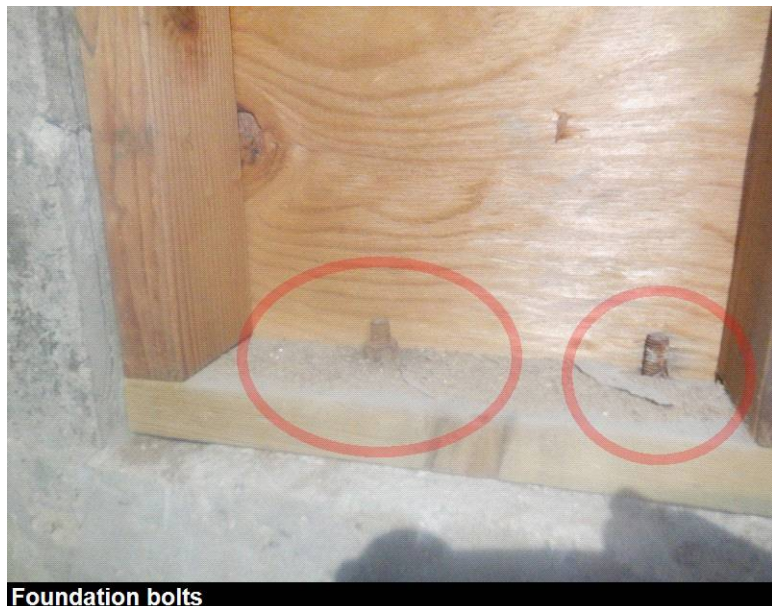
Foundation bolts

**\*HOMEBUYER HIGHLIGHT\*FOUNDATION BOLTED-** Foundation bolting typically means that bolts are added to improve the connections between the wooden framing members of a building and its concrete foundation. Usually this means adding bolts through the piece of wood that lies flat on top of the foundation, referred to as the sill or mudsill, into the concrete. Earthquake bolting became standard practice in Southern California in the 1930's. The visible portions of this structures bottom plate do show foundation bolts.

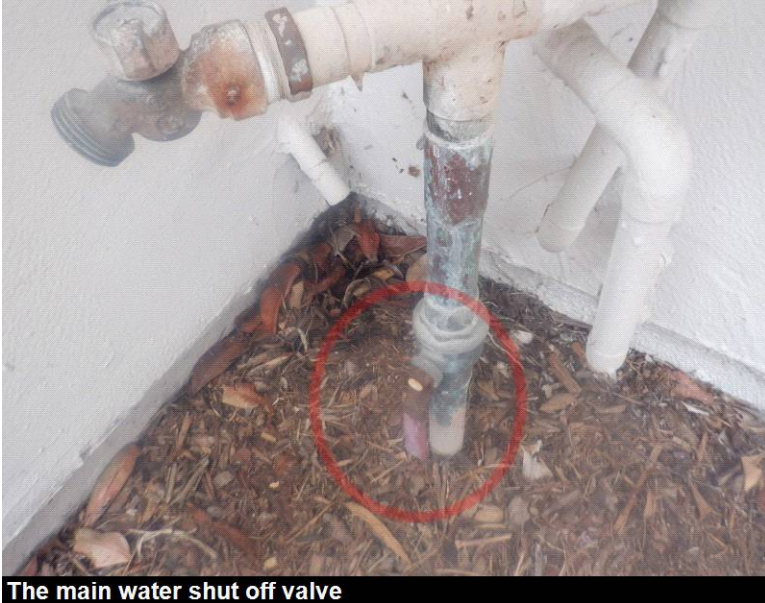
The main water shut off valve is located at the rear of the structure.

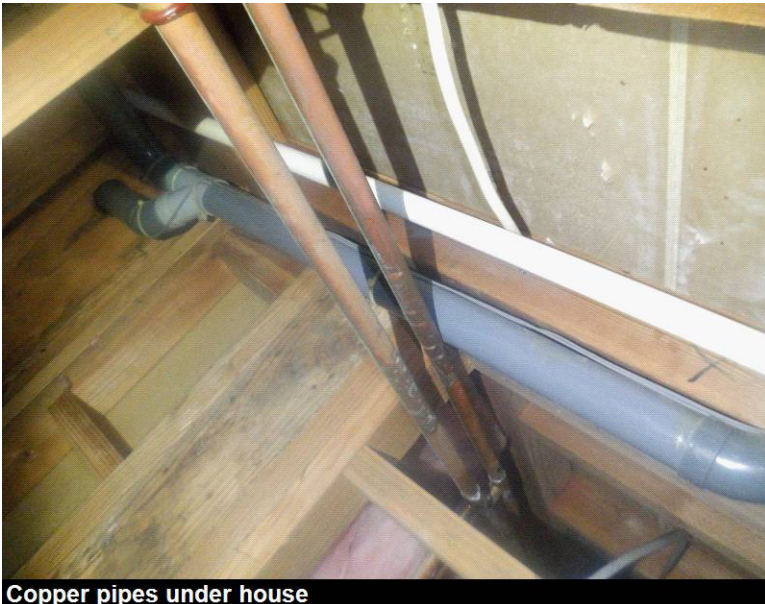
Copper pipes under house

**\*HOMEBUYER HIGHLIGHT\* COPPER PLUMBING SUPPLY LINES-** This structure has copper supply lines for plumbing where visible. Copper is durable and naturally corrosion resistant. Copper piping has been the favored material for pipes for over 70 years. Copper piping is environmentally friendly and is also recyclable.

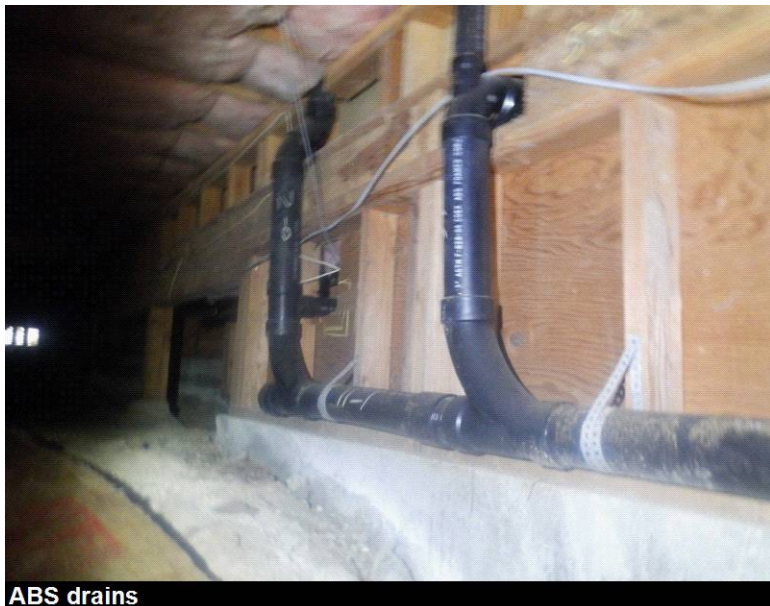
ABS drains

**\*HOMEBUYER HIGHLIGHT\* ABS DRAINS-** The visible portions of the plumbing drain lines consist of ABS. ABS pipe and fittings are made from a thermoplastic resin called Acrylonitrile-Butadiene-Styrene (ABS for short). ABS pipes are resistant to most acids, alkalis and salts. However, they are not resistant to aromatic and chlorinated hydrocarbons. This piping can be used above or below the ground, but ABS is more likely to deform when exposed to the sun and must be wrapped or painted if used in areas where exposed.

No defects were visible at system drain lines, drainage adequate when tested.

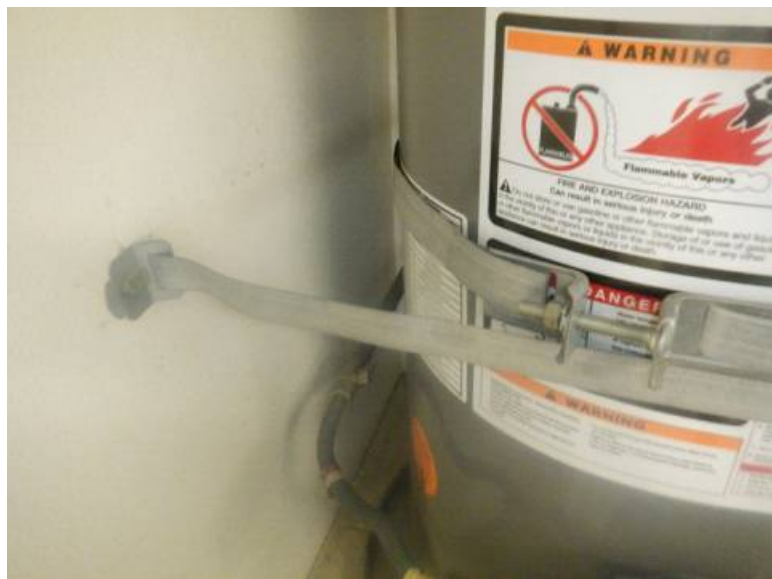
Earthquake strapping of water heaters is required in California residences. The water heater is properly earthquake strapped.

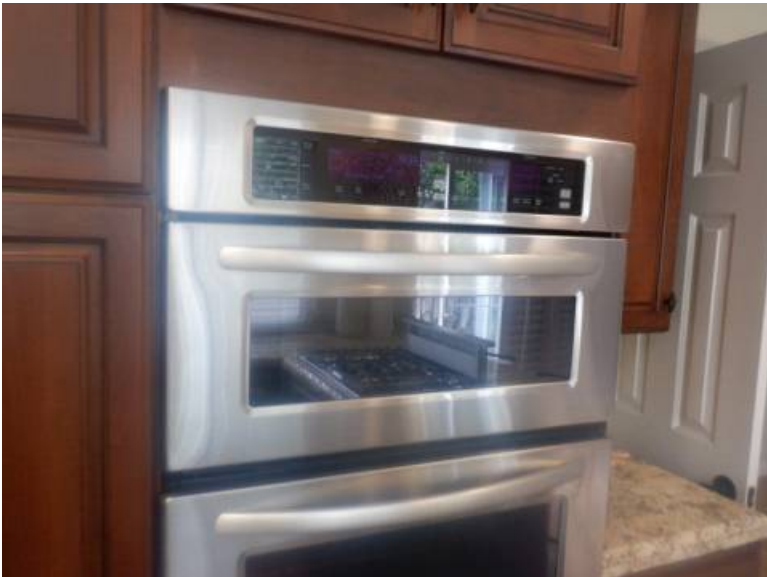
**9.16 Microwave Comments:**

No defects noted at microwave.

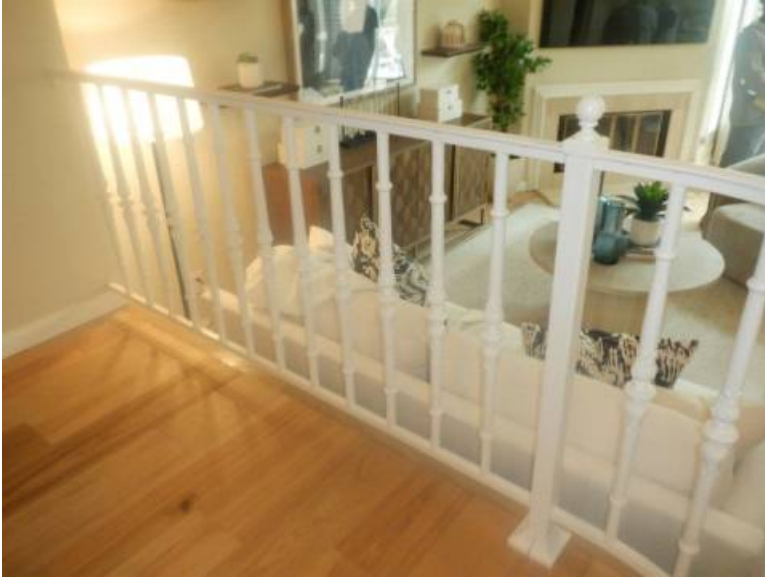
The gaps at the railings and/ or treads are larger than allowed by current building standards. The maximum distance between balusters or between a post and baluster, in the California building code, is 4 inches. The space between the finished floor and the bottom rail must not exceed 4 inches. In addition, the minimum balustrade height is 42 inches. Though replacement of railings are not required to transfer title of property, any newly installed railings must meet current standards.
